GRANIT
QUALITY PARTS

MASTER BRAKE CYLINDER

PRODUCT BENCHMARK

TEST REPORT NO. 2022-01/1203 PM-30544

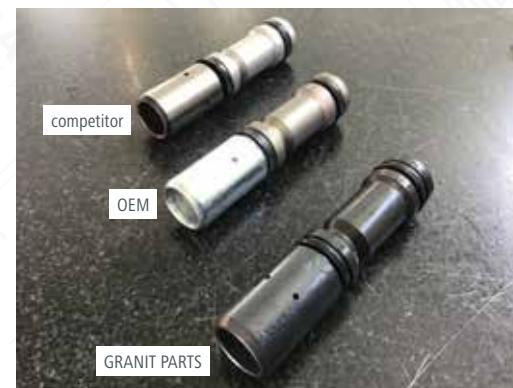
Figure 1: The master brake cylinders from the three suppliers. Dismantled MBC.
Visual assessment and dimensional comparison of the installed components.

All functional dimensions of the three MBCs are identical and are within the tolerance zone. No deviations were found.

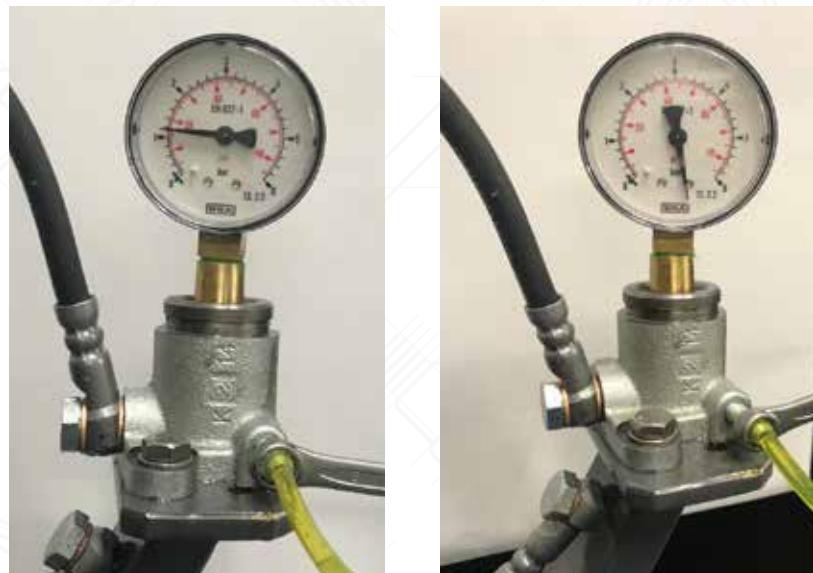
Figure 7 and 8: Possible pressure build-up before venting and after venting.

The mounting of the MBC and the assembly of the brake hoses could be done without any problems. The threaded holes provided for attaching the brake hoses were made professionally and cleanly by all manufacturers. The subsequent venting of the three MBCs was also carried out smoothly. All three MBCs are in accordance with the function.
